Case Report

Vacuum-assisted closure for management of a traumatic neck wound in a horse

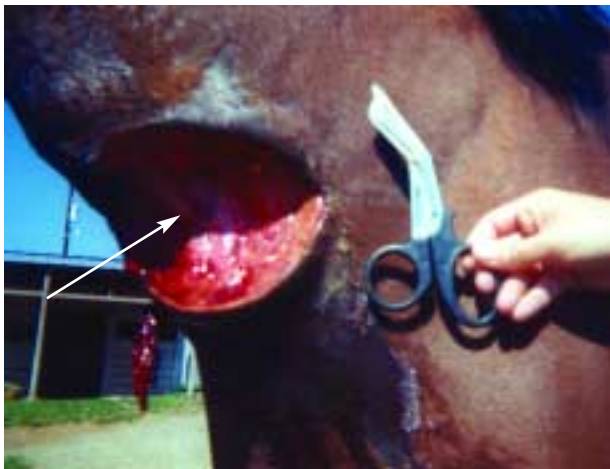
Fig 1: Appearance of the wound on the left side of the neck 24 h after injury. The left jugular vein has been dissected from the surrounding tissue (arrow) in the depths of the wound. A blood clot hangs from the ventral margin of the wound.

A nine-year-old Arabian gelding was discovered in a wooded pasture with 2 large wounds on the ventrolateral aspects of the neck, in the caudal third of the cervical area (**Figs 1 and 2**). The

On presentation 1 to 2 h after injury, the wound on the left side of the neck measured approximately 21 x 18 cm in area and 8 cm in depth at its deepest point. The left jugular vein was intact but had been dissected from the surrounding tissue for at least 6 cm of its length (**Fig 1**). The trachea and oesophagus were visible in the depths of the wound, but were undamaged.

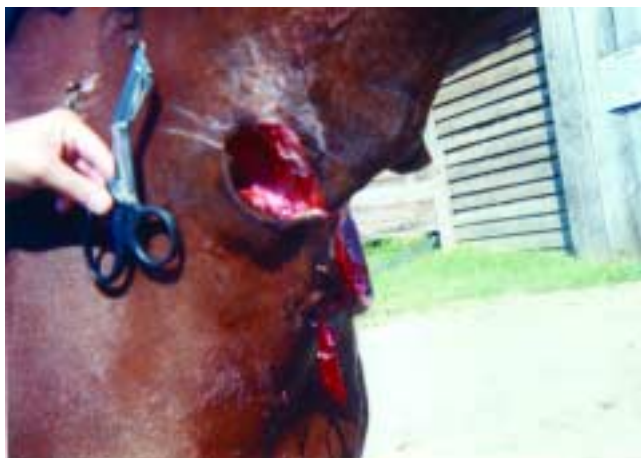
Fig 2: Appearance of the wound on the right side of the neck 24 h after injury. The extent of the tissue defect on the left side of the neck is readily apparent.

The wound on the right side of the neck was smaller, measuring approximately 13 x 9 cm in area and 5 cm in depth at its deepest point (**Fig 2**) and no vital structures were exposed. The left and right wounds did not appear to communicate, although they were separated by only a narrow isthmus of tissue. On physical examination, all vital signs were within normal limits.

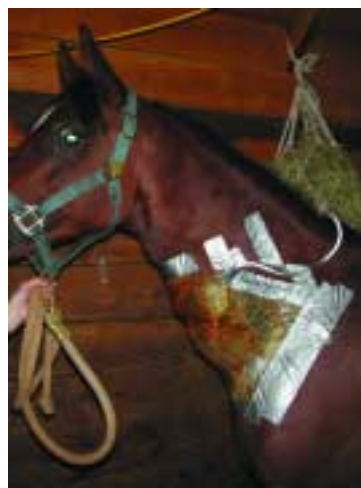
Fig 4: Collapse of the foam dressing and adhesive barrier drape confirms that an airtight seal has been achieved.

As soon as the adhesive drape was in place, the vacuum pump was turned on at a continuous pressure of 125 mmHg. It was important to begin negative pressure as soon as the drape was applied, as it helped to create an airtight seal over the wound. Collapse of the foam and adhesive drape and, after several mins, the presence of serum in the evacuation tube confirmed that an airtight seal had been achieved (Fig 4).

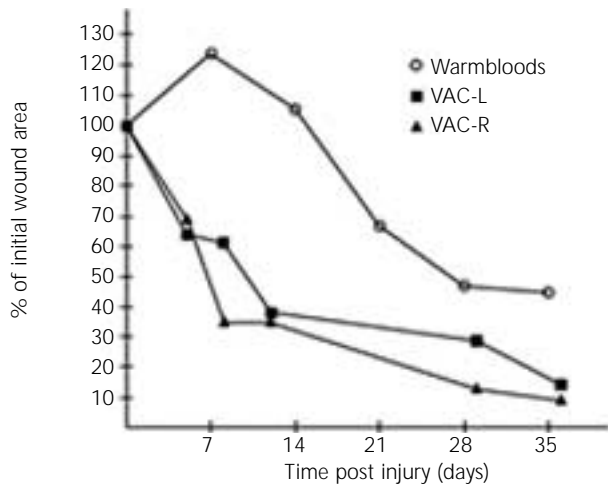
Fig 5: Comparison of the rate of wound healing between the case presented here and a recent study of wound healing in Warmbloods (Wilmink et al. 1999). VAC-L and VAC-R denote the wounds treated with vacuum-assisted closure on the left and right sides of the neck, respectively.

The foam dressing was replaced and the wounds evaluated every 3 to 4 days. Wound dimensions were measured on Days 5, 8, 12, 29 and 36 post injury (Table 1). As shown in Figure 5, wound area decreased rapidly between Days 2 (initiation of VAC therapy) and 5, and continued this rapid reduction in size until Day 12. Reduction in wound area was slower between Days 12 and 29 post injury. Nevertheless, wound areas on Day 29 were 29 and 13% of the initial area on the left and right sides of the neck, respectively.

Vacuum-assisted closure greatly facilitated second-intention wound healing in this horse. Subjectively, both wounds healed much more quickly and with less scarring than expected for the size and depth of the tissue deficits. Comparison with a recent study on wound healing in horses confirmed our clinical impression (Fig 5).

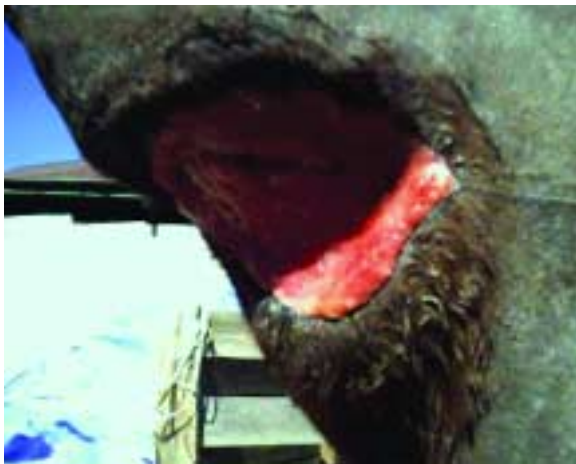
Fig 6: Appearance of the wound on the left side of the neck on Day 14 post injury.

Wound depth steadily decreased as granulation tissue filled the defect (Table 1; Fig 6). By Day 29 post injury, granulation tissue filled the wounds sufficiently that VAC therapy could be discontinued (Fig 7). Aspiration of fluid from the wounds also steadily decreased during treatment. For the first few days, the 1 litre flask required emptying every 10 to 12 h. By the end of the 29-day treatment period, the flask was not full even after 48 h.

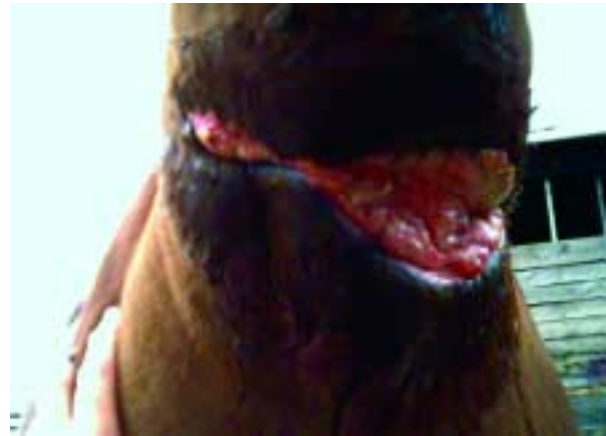
Fig 7: Appearance of the wounds (ventrodorsal view) on Day 29 post injury.

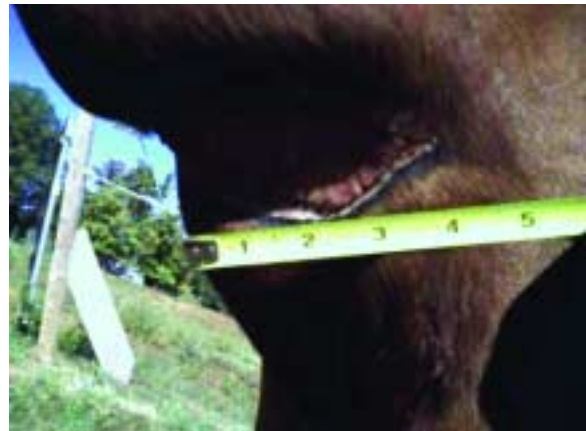
Fig 8: Appearance of the wound on the left side of the neck on Day 36 post injury.

In the week following discontinuation of the VAC system (between Days 29 and 36), the wounds contracted further and the granulation beds became level with the skin surface (Fig 8). Skin grafting was offered at this time but was declined by the client. Despite that, the final functional and cosmetic results were considered very good. The horse had normal mobility of the neck, and the amount of scarring was acceptable to the owner (Fig 9).

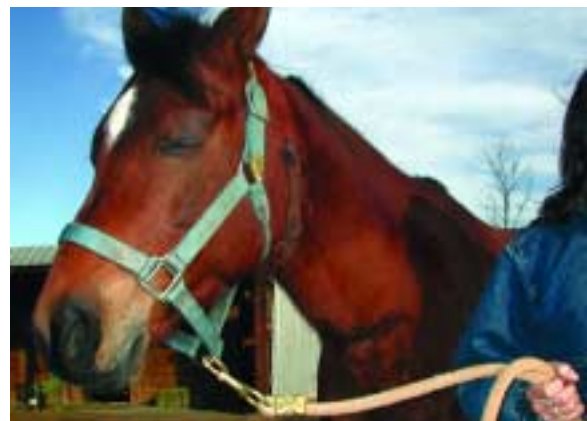
Fig 9: Appearance of the wound on the left side of the neck 4 months post injury.
